# MUNITIONS STORAGE SITE SOUTHWEST OF SHANG-JAO, CHINA

NPIC/R-1271/64

COORDS: 28-22N 117-54E NPIC TARGET NO: None

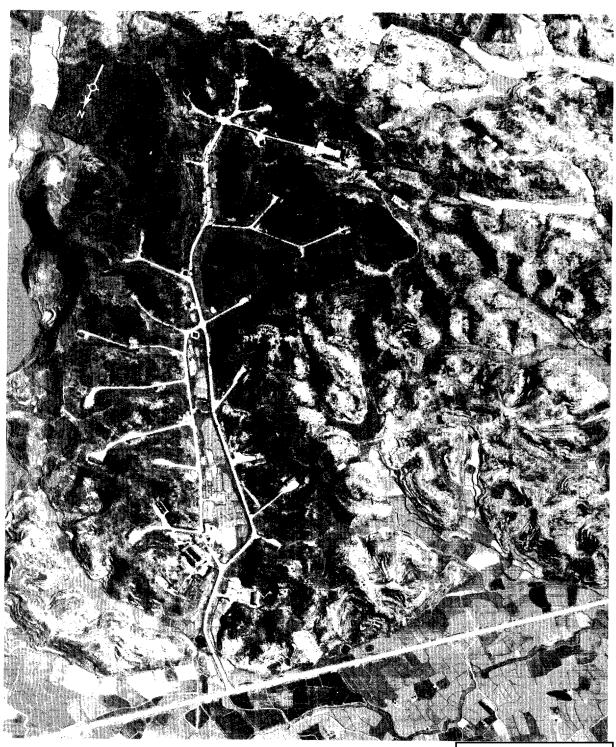
FIGURE 2. MUNITIONS STORAGE SITE SOUTHWEST OF SHANG-JAO, CHINA,

Storage Buildings. There are 26 storage buildings of three different sizes at the site (Figures 2 and 3). All have end walls, resembling walls for blast protection, that extend above the roof of the building. None of the buildings are revetted; however, they are situated in terrain that provides natural protection. Adjacent service aprons permit easy

access to the entrances which are situated on one side of the long axis of the buildings. The small size buildings have one entrance; the two larger sizes have two. All entrances are covered by a small roof overhang. One building has two low, gable-type roof ventilators (Figure 4).

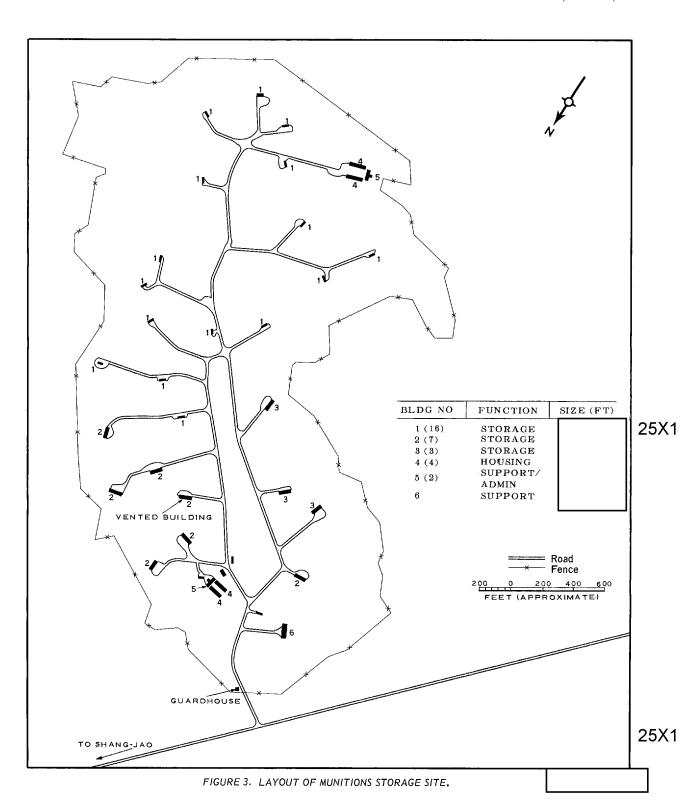
Security. The site is single fenced. A small guardhouse is at the single entrance. Patrol trails and lookout points around the periphery of the site indicate that the storage area is kept under surveillance.

Housing and Administration. Groups of three adjacent buildings (items 4 and 5) situated at each end of the site probably serve for housing, support, and administration. A probable vehicle shed (item 6) and several small support/administration buildings are near the entrance to the site.
